Using Acceleration Enveloping on Sleeve Bearings

By Wane Wier • SKF

Dragan Trivanovic • Senior Reliability Engineer, Teckcominco

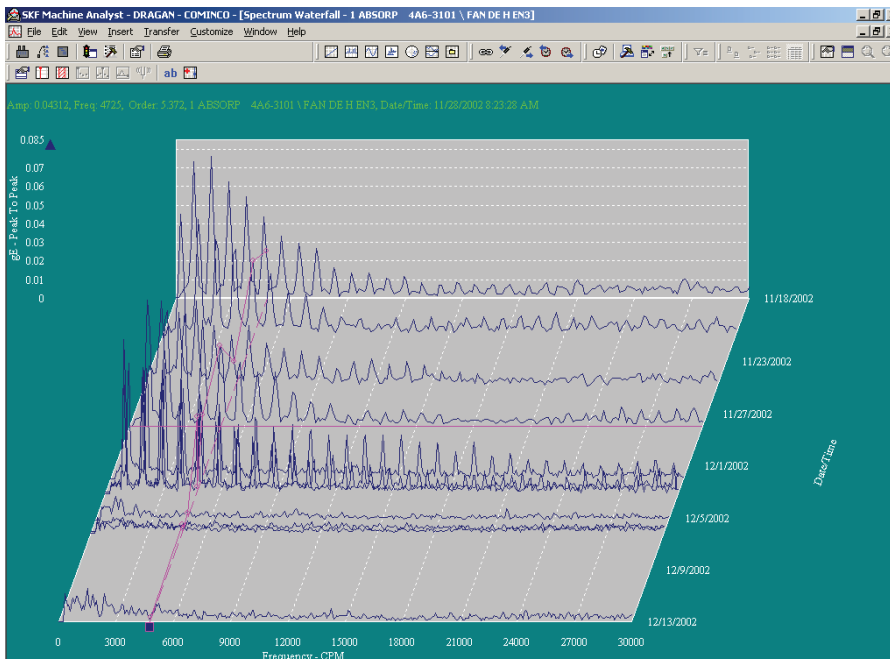
Fig. 2 shows the fan's enveloped acceleration waterfall spectrum. We observe signs of looseness indicated by 1/2X harmonics. The drive end bearing was indeed damaged and was replaced after the 12/1/2002 measurement.

Vibration velocity and temperature were also measured. The velocity readings did not indicate any bearing problems, although there was a slightly elevated 1X. Engineering suspected that there was dirt on the runners.

The temperature trend on the failed bearing never reached alarm setpoints. In fact, temperature values remained relatively stable throughout the entire period shown in the waterfall spectrum. The bearing probably would have been lost completely if only temperature readings were used.

Figure 2. Absorption fan enveloped acceleration waterfall plot.

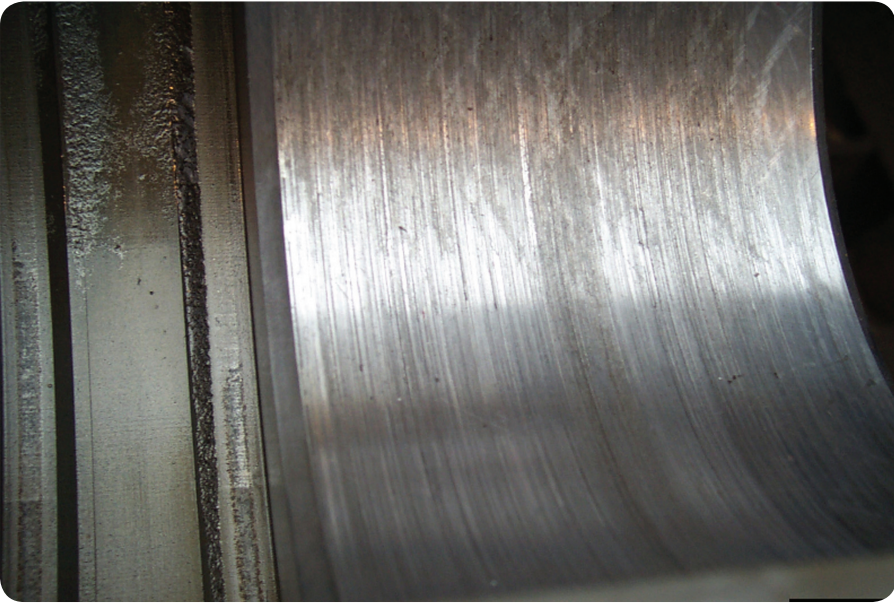
In **fig. 3** and **fig. 4**, the pictures illustrate the damaged bearing and the scraping damage to the shaft.

As seen in the pictures, both the bearing and the shaft were damaged. The bearing wear was 8 mils and the shaft wear was 12 mils. In this case, sanding the shaft down using 600 grade sandpaper and scraping the bearing allowed both to be salvaged, and took only six hours to perform. Had this bearing completely failed, the estimated downtime would have been seven days and would have resulted in more than \$700 000 USD in lost revenue.

Figure 3. Absorption fan, bearing damage.

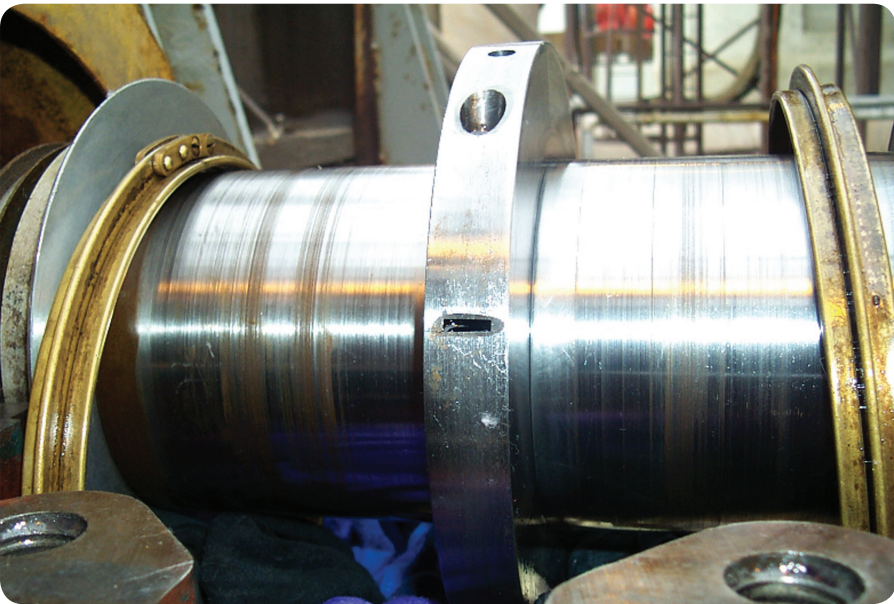
Figure 4. Absorption fan, shaft damage.

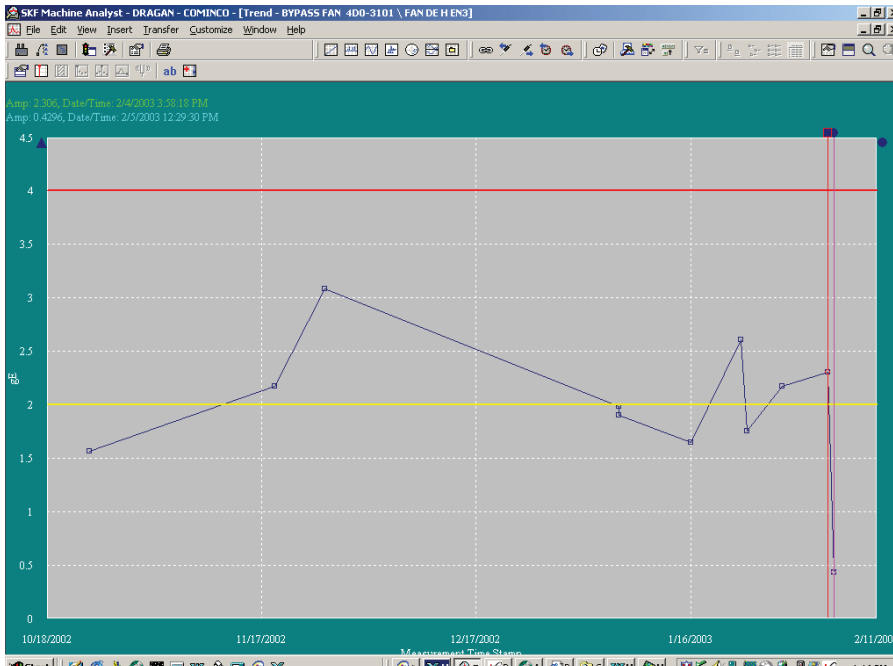
Fig. 5 shows the enveloped acceleration measurement's overall trend, with some relatively high readings going in and out of alert. The last two readings were taken before and after the bearing was replaced. The day before the bearing was replaced, the value was about 2,3 gE, which dropped to 0,4296 gE after the bearing was replaced.

Figure 5. Bypass fan, enveloped acceleration overall trend.

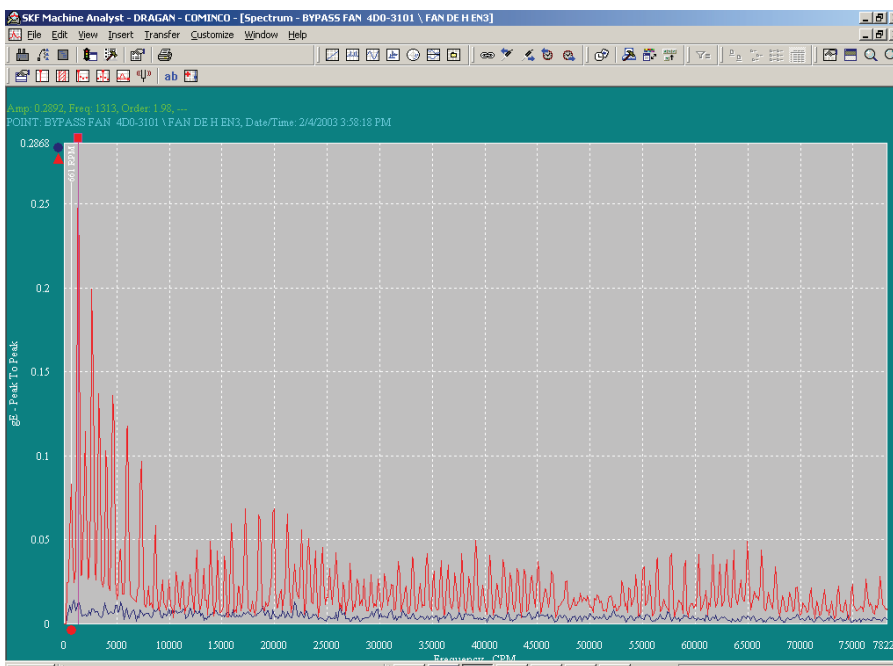
Figure 6. Bypass fan, overlaid enveloped acceleration spectra for last two measurements.

Fig. 6 shows the overlaid spectra of the last two readings: one before (shown in red), and one after bearing replacement. The red spectrum shows signs of looseness, with 2X being the highest peak, which was caused by shaft movement due to wear.

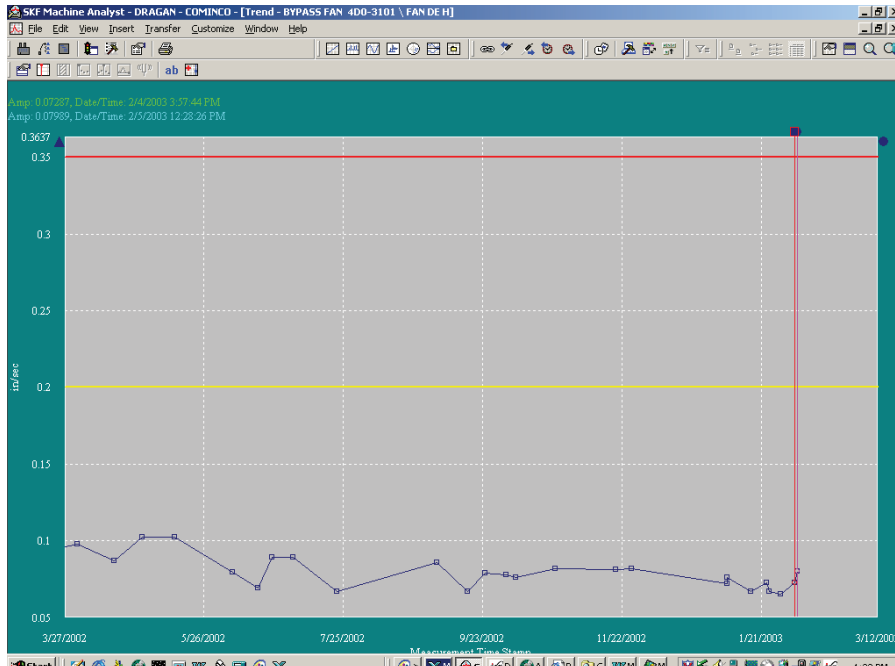
As with the previous case, the velocity trend did not show much. However, the velocity spectrum did have some activity (→fig. 7 and fig. 8). The velocity spectrum has high peaks that belong to motor speed and 1X, 2X and 3X components caused by misalignment. Fan speed harmonics (660 RPM), shown in red, are very low in the velocity spectrum.

Figure 7. Bypass fan, velocity trend.

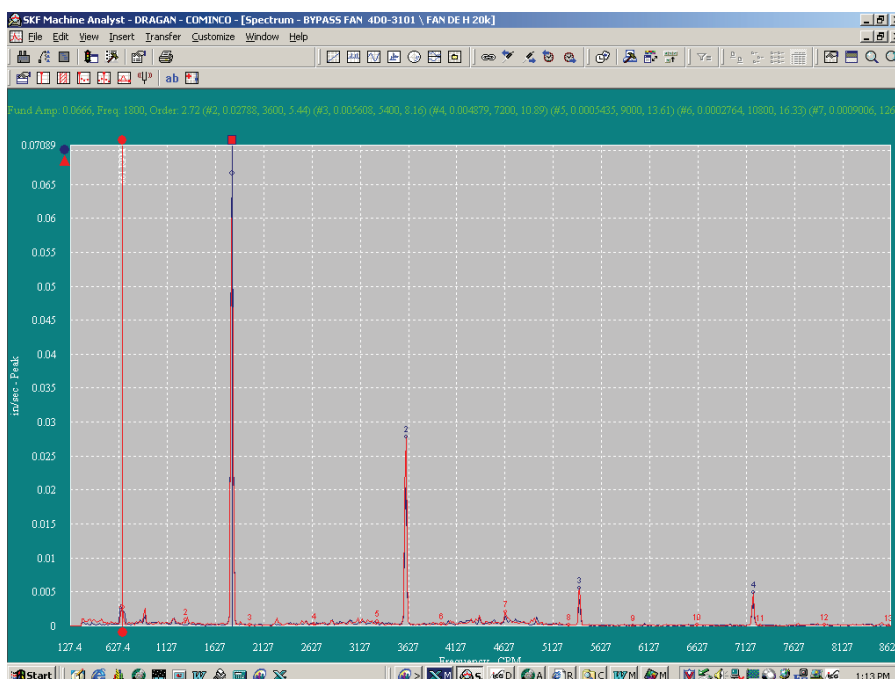
Figure 8. Bypass fan, velocity spectrum.

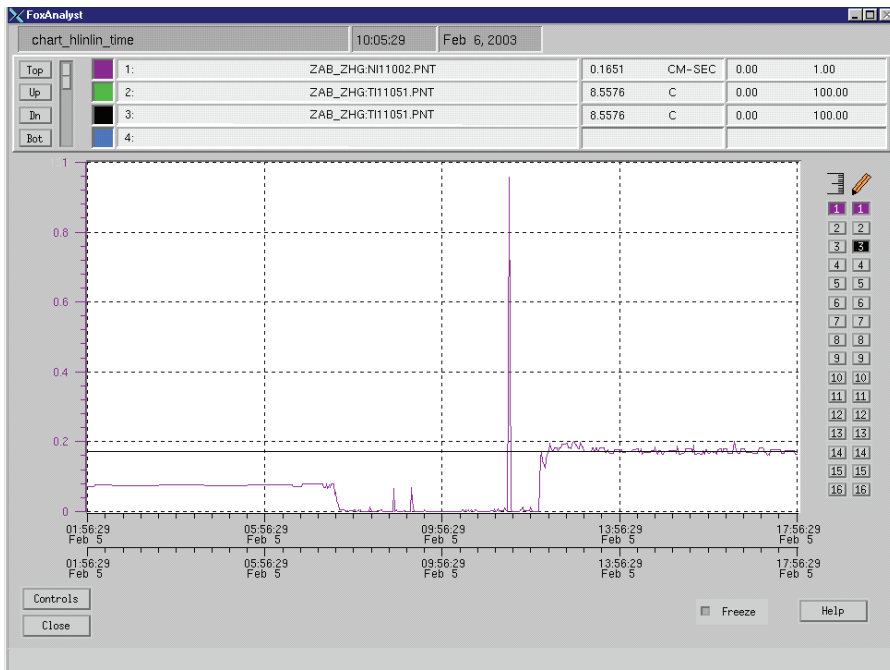
In **fig. 9**, the left part of the trend shows the velocity readings before the bearing was replaced, and the far right side shows the readings after the bearing was replaced. The spikes created between the two were created during the repair.

An interesting observation is that the far right part of the trend actually shows higher velocity readings than before the bearing was replaced. This is because the new bearing was installed on the same damaged shaft. It turns out that the shaft was worn by 22 mils, and to replace it would have been a four day job. It was decided that we should wait until the next planned shut down to make repairs, and in the meantime investigate the feasibility of performing a repair “in place” using a Belzona or similar product instead of replacing the entire shaft.

Figure 9. Bypass fan, DCS trend.
