Detection of Electrical Fluting in Rolling Element Bearings

By Dr. Robert M. Jones • SKF

Abstract

Random electric currents will damage bearing rings and rolling elements. Detection of this damage using enveloped acceleration (gE) is shown by the examples given.

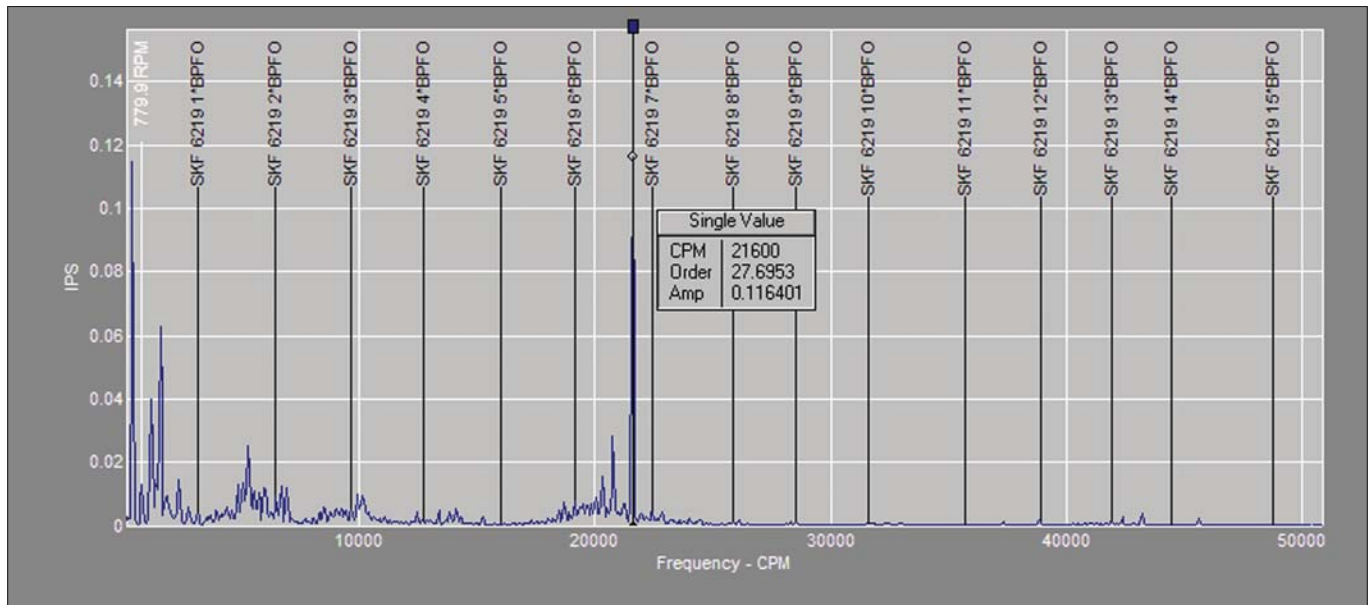
Figure 1. A problem was suspected in February. The velocity spectrum does not show any indications of a bearing problem; however, the spike of energy at 21 600 CPM is a red flag that there are electrical problems with the controlling SCRs.

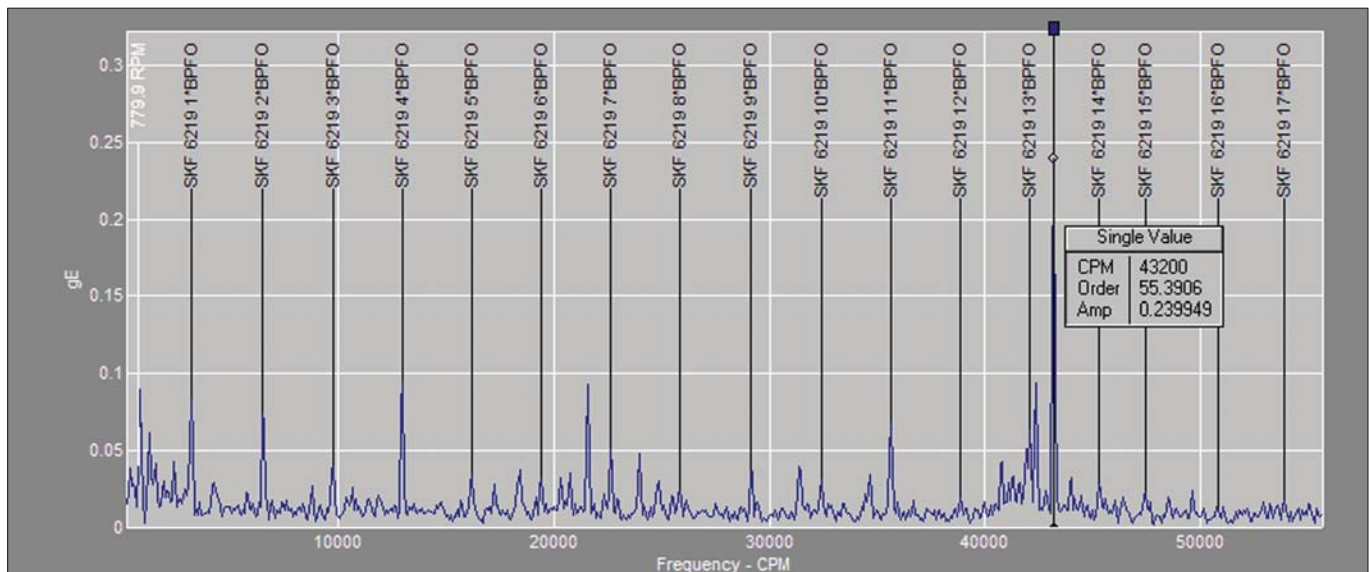
Figure 2. An acceleration enveloped spectrum taken on the same bearing. Clearly, there is something happening with the bearing's outer race. However, at these amplitudes, there is no call to change the bearing. At this point, all that is needed is to alert Maintenance that something is going on.

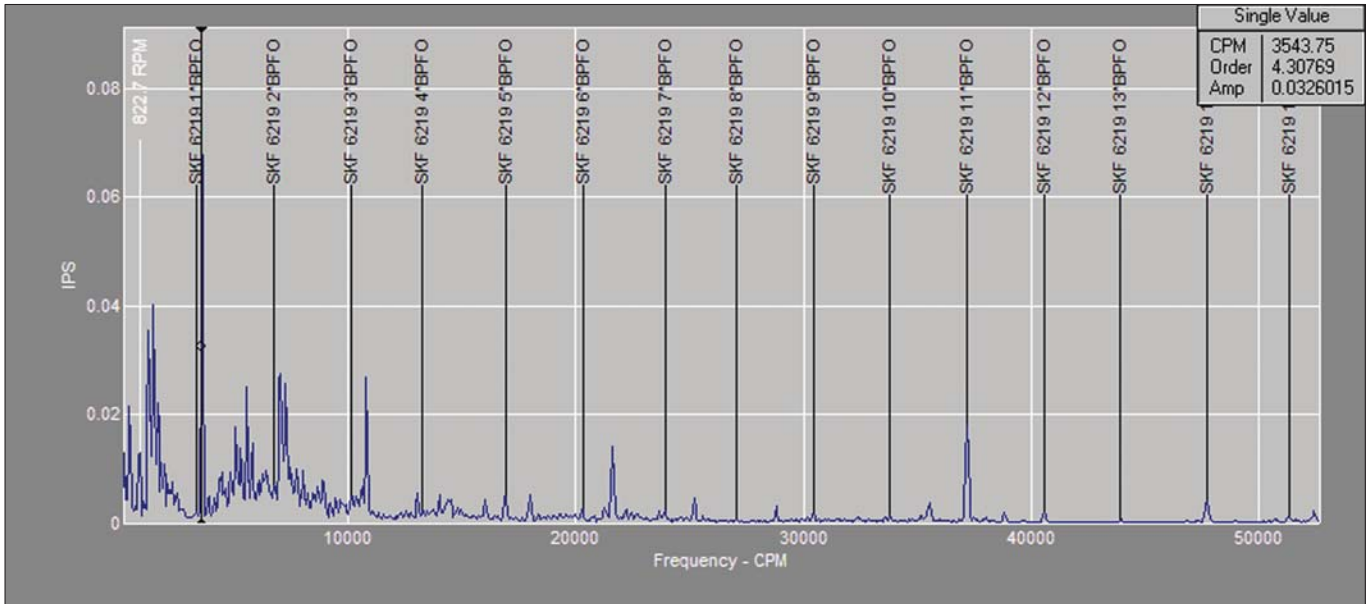
Figure 3. The velocity spectrum shows small indications that a problem is developing in the outer race, but at these amplitudes, there is no need for concern.

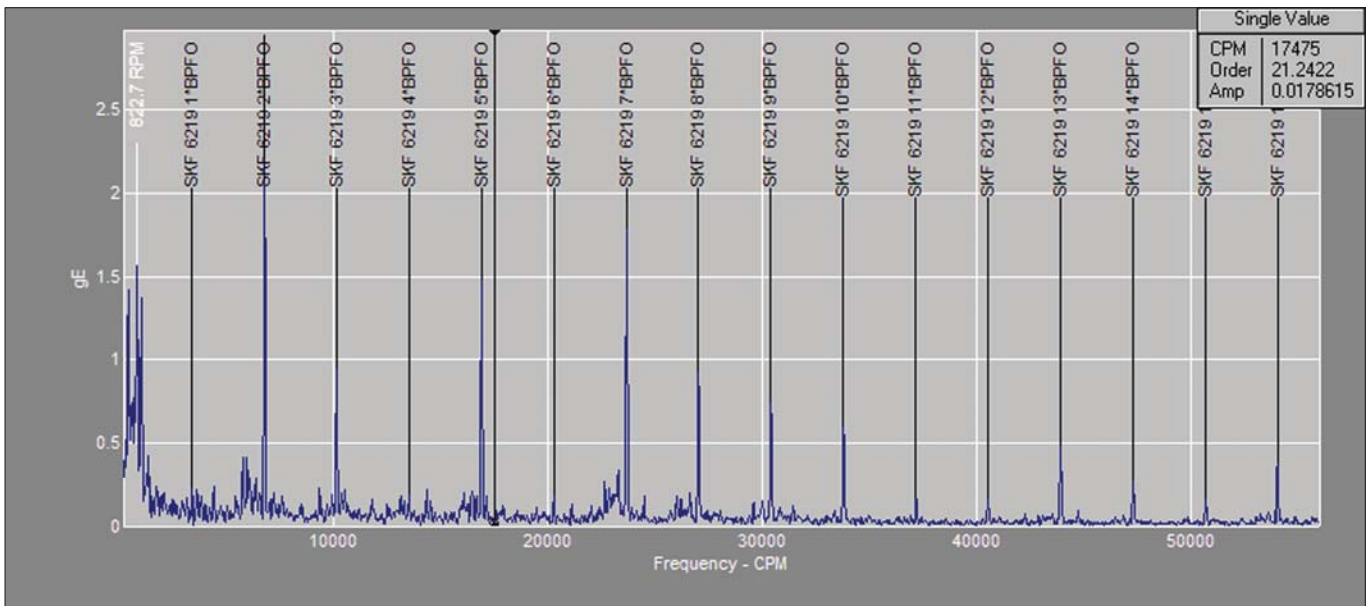
Figure 4. Enveloped acceleration clearly shows there is a serious problem.

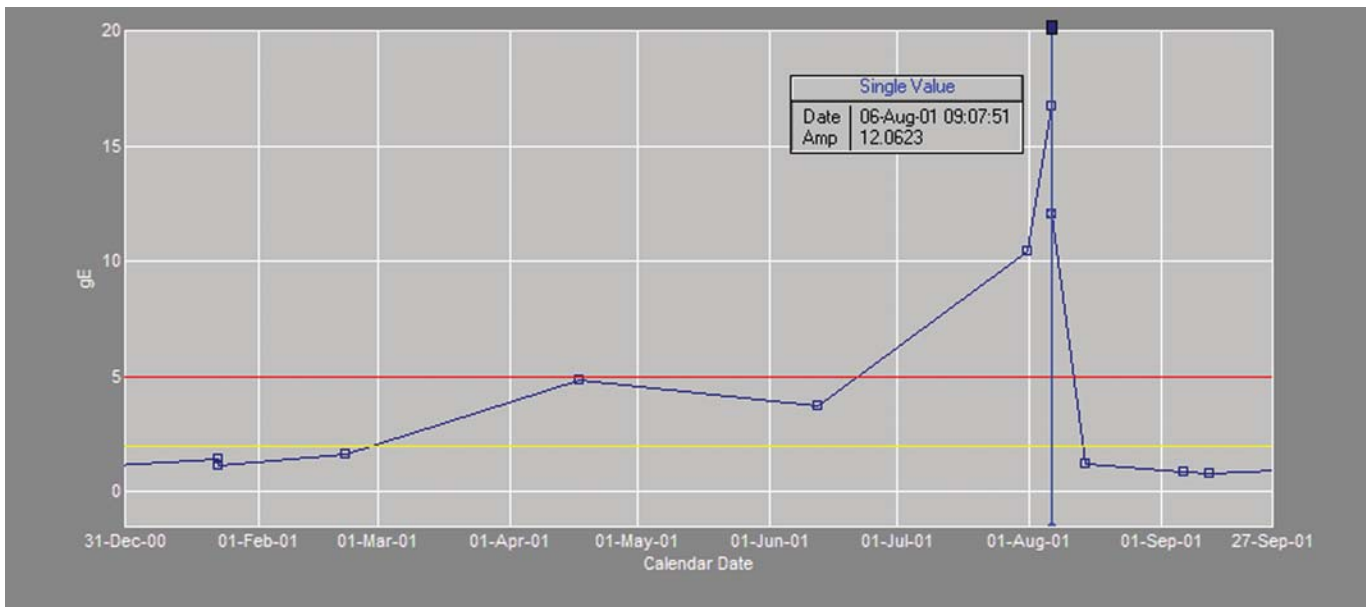
Figure 5. Trend of acceleration enveloped overall amplitude.

Clearly, this bearing is damaged and should be replaced as soon as possible. The trend shows it was replaced shortly after August 6. A photo of the actual bearing is shown in **fig. 6**.

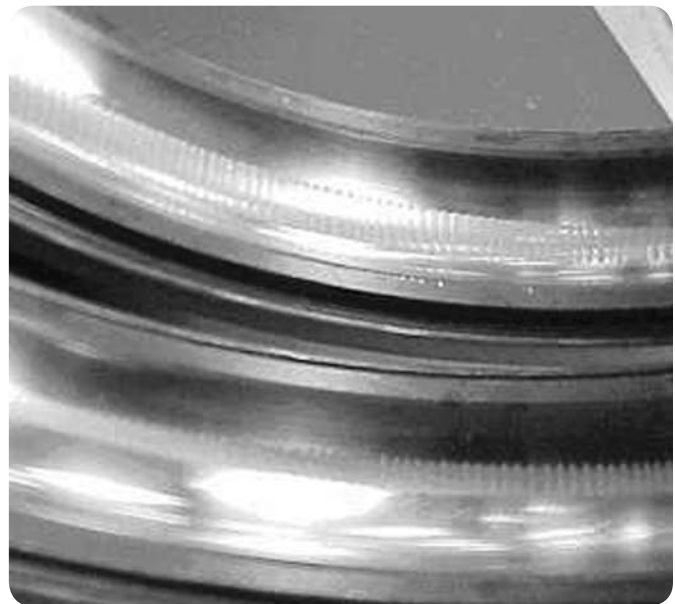
Needless to say, bearings are not designed to be conductors of electricity, so the result is a damaged bearing. The damage is seen in a very characteristic pattern known as fluting. Close observation of the contact surface of the bearing ring will disclose a series of ridges and groves that lay in the ring from side to side, often described as looking like a washboard. If you pass your fingernail around the inner surface of the ring, these ridges and valleys are readily apparent.

What has happened is that the current has performed a long series of micro welds and has eroded the surface to form this pattern. Some interested party has probably figured out the math involved to generate this well known pattern, but for the purpose of this paper, just accept that it is a well known phenomenon caused when electricity passes through the bearing on the way to ground.

Figure 6. Damaged bearing.
