Dynegy – Wireless MCT Implementation

By Gary Gbur, Wane Wier and Torsten Bark • SKF
Brian Baldwin • Dynegy – Reliability Engineering Manager

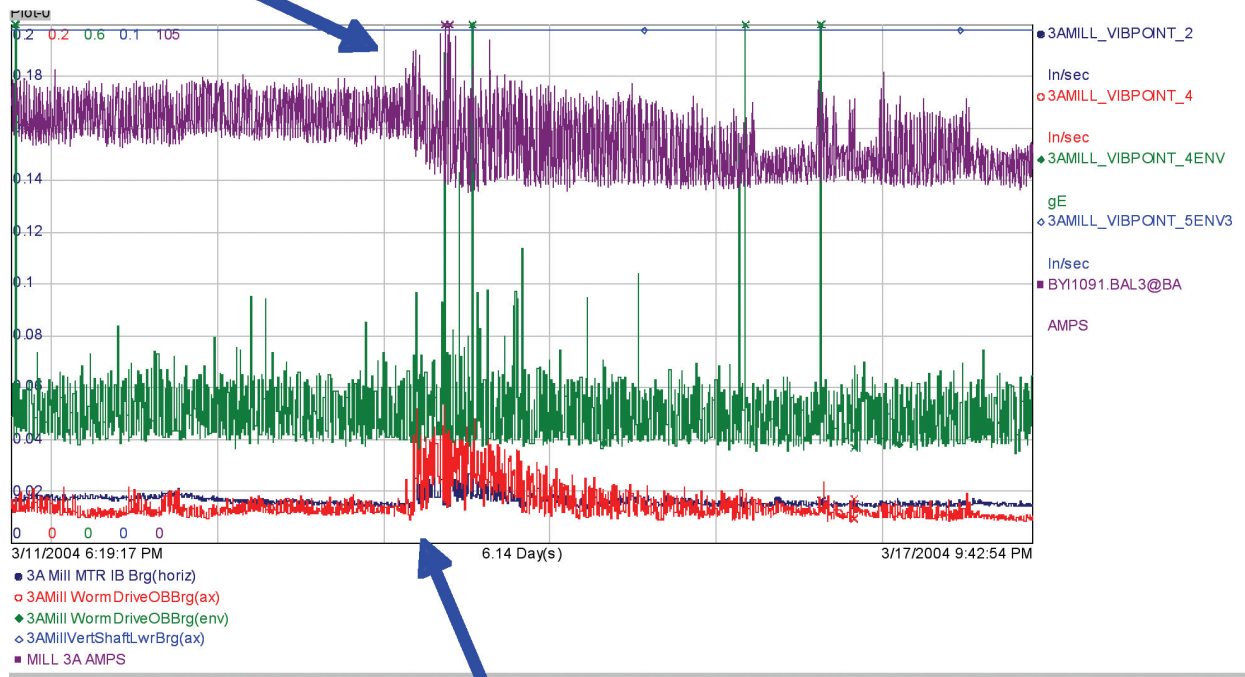
The system was installed and fully operational in one day, and the actual installation took place on March 9, 2004. On March 15, only five days after installing the SKF solution, the pulverizer experienced a bearing failure on the Number 2 grinding roll. As Dynegy put it, “The [SKF] system was instrumental in notifying plant personnel of a change in operating characteristics of the pulverizer. A review of the PI Historian showed the correlation between changes in pulverizer motor current and the vibration trends on the inboard motor bearing, outboard worm shaft bearing and the Number 1 and Number 3 rolls, prompting the PdM Engineer to take more in depth vibration data with a portable analyzer”. What the plant personnel saw is shown in **fig. 8**.

Fluctuation in Motor Current

Increase in Vibration Observed on Motor Inboard Bearing and Worm Shaft Outboard Bearing

Figure 8. Plot showing the correlation between motor current and bearing related vibration data.

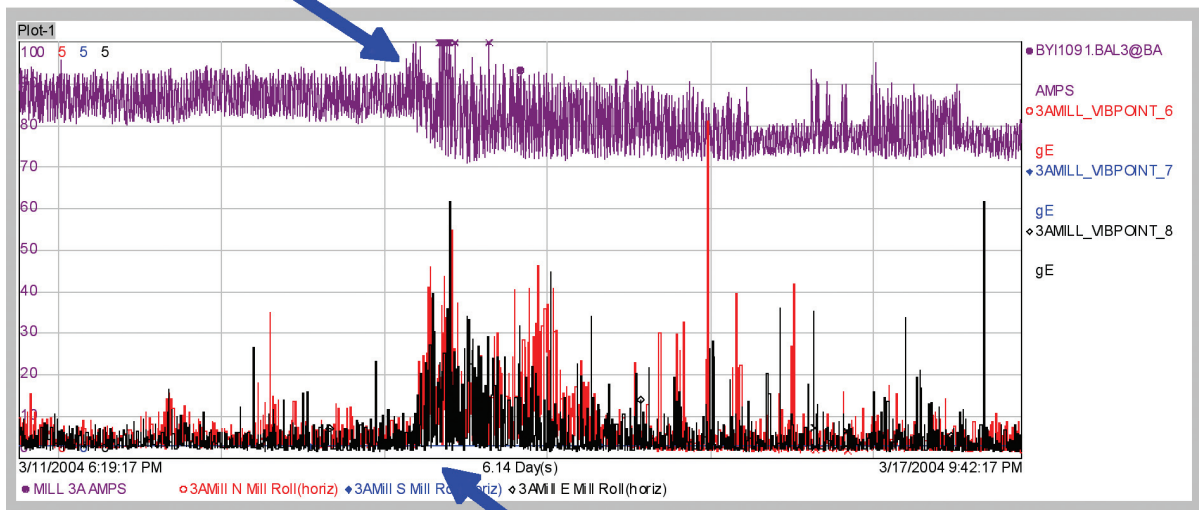
Motor current was also plotted along with the Number 1 and Number 3 grinding roll vibration data. The data from these rolls came from the SKF system. Even though the failure did not occur within these rolls, the vibration from the failed roll Number 2 was strong enough that the MCT’s were able to detect it. Again, the plot (→**fig. 9**) shows a distinct correlation between the motor current and the vibration data from the rolls.

Fluctuation in Motor

Increase in Vibration Observed on Number 1 and Number 3 Rolls

Figure 9. Plot showing the correlation between motor current and the grinding roll vibration data.

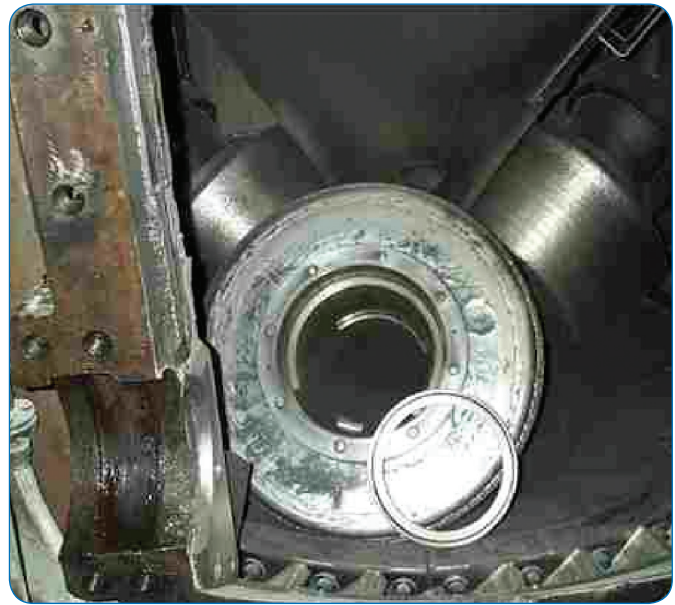
The vibration data collected by the PdM Engineer, coupled with an unsuccessful attempt to adjust the grinding roll, forced a visual inspection. This inspection revealed the Number 2 grinding roll bearing had failed, and the roll had dropped into the bowl and come in contact with the cone assembly (→fig. 10).

Both bearings in the roll had failed and had actually disintegrated. The root cause is suspected to be a lack of oil in the journal, which would contribute to the relatively rapid failure. The journal shaft was also distorted from the heat, and the inner races of the bearing were stuck to the shaft. Furthermore, the bolts holding the upper journal housing to the grinding roll were sheared off, causing the grinding roll to slide and hit the center feed pipe, and even breaking a piece out of it, as shown in fig. 11.

Figure 10. The failed bearings.

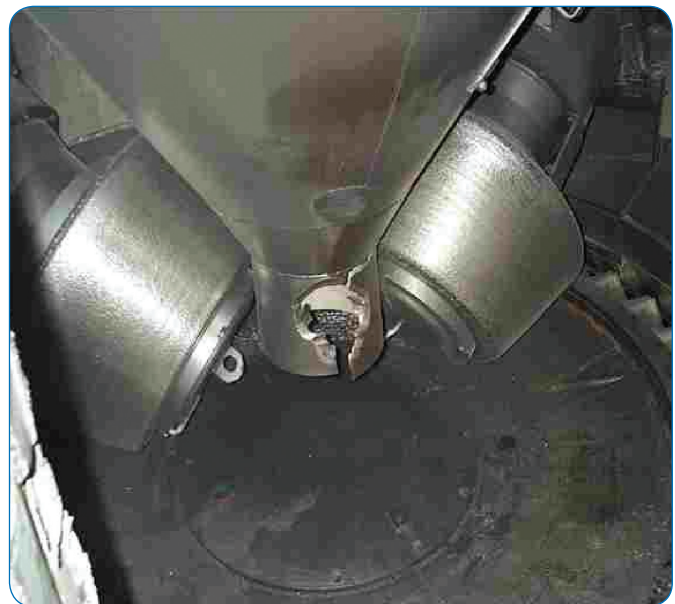
Figure 11. The damaged center feed pipe.
