Industry: Power Generation

Machine Type: Electrical Generator Gearbox

A large windmill power generating project in Northern California experienced abnormal gear wear. Gearboxes are used to transfer energy from the windmills to the generators. The gears wore fairly quickly, becoming excessively loose, much more quickly than the design specifications. No particular failure mechanism could be determined:

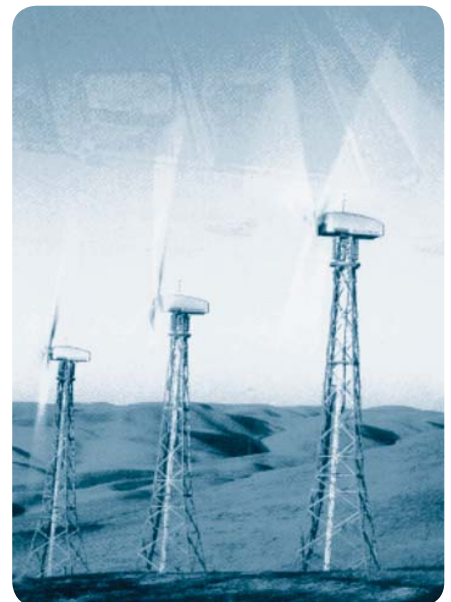
The oil analysis of used oils by the laboratory found oil was of proper type and grade. There were very high particulates and wear metals from both the gears and the bearings. Tribological examination of the gears and the bearings showed evidence of severe abrasive wear.

- Deep gouges and grooves in the bearing surfaces
- Loss of metal on the gear teeth, with deep gouges and grooves
- Heavy notched steps worn into dedendum of the gear teeth
- Contact fatigue at the pitch line of the gear teeth

It was a very dry, dusty environment, with a lot of airborne dust. Fine airborne dust was getting into the gearboxes through the breather lines. The dust was getting caught between the bearing surfaces and the gear teeth and acting as an abrasive. The breather lines had no filters.

The hard dust particles were cutting, gouging and scraping away the bearing surfaces and gear teeth, leaving the deep grooves and notching the gear teeth. Looseness in the bearing and gears resulted. Dust particles trapped between the gear teeth at the pitchline as the gear teeth meshed were causing the entire load to be transferred at a point contact instead of across the entire width of the gear tooth, resulting in contact fatigue failures at the pitchline.

Lube systems were drained and flushed to remove all dust, dirt and debris. The operator put installed filters on the breathers and installed surface conforming plastic barriers (“bags”) on the top of the breather tubes. This allowed the system to continue to “breathe” (gas volume to expand and contract with changes in temperature and atmospheric pressure), but prevented dust from being ingested into the system.
