Knowledge Base Article

Product: TKSA 60, TKSA 80 Shaft Alignment Systems

Abstract

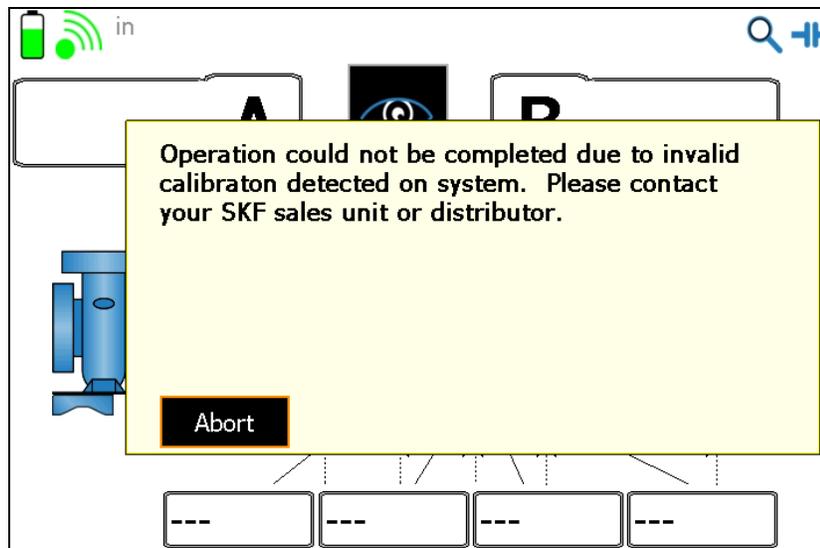
When an alignment job is performed after installing the TKSA V2 upgrade kit, the error message, *“Operation could not be completed due to invalid calibration detected on system. Please contact your SKF sales unit or distributor,”* is displayed. This article provides instructions on how to copy the necessary calibration file onto the TKSA Display Unit to resolve the error.

A calibration file is provided on a USB storage device enclosed with each TKSA 60/80 V2 upgrade kit. This calibration file must be installed on the Display Unit after the firmware upgrade to ensure accurate measurements. If this file is not copied over, the calibration error message shown in Figure 1 will be displayed when an alignment job is performed.

Figure 1. Invalid calibration error message

Follow the procedure below to copy the supplied calibration file onto the TKSA Display Unit.

CAUTION! The USB storage device contains a calibration file **ONLY** for those measuring units which are enclosed with it. Do not use with any other measuring units.

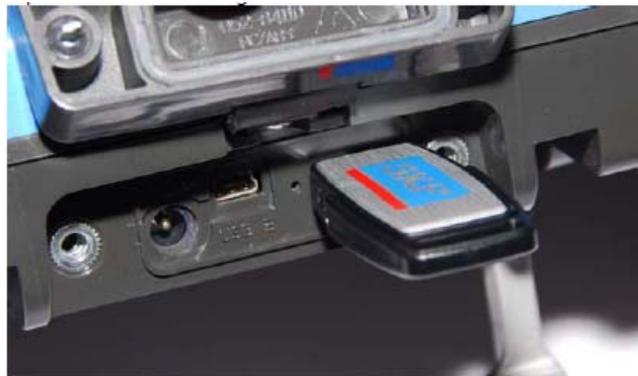
Figure 2. Insert USB storage device

1. Connect the provided USB storage device to the **USB A** connector [Figure 2] on the TKSA 60/80.

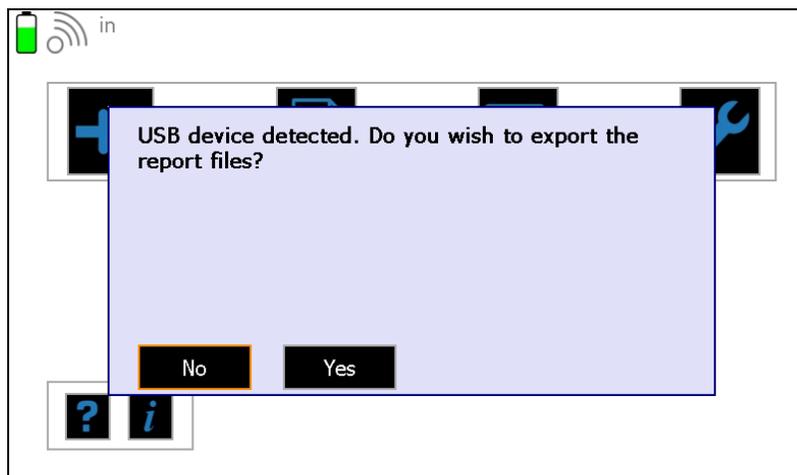
Figure 3. USB device detected

2. When the USB device is detected, a confirmation dialog [Figure 3] will be displayed. Select **Yes** to export any reports from the Display Unit onto the USB stick, if desired.

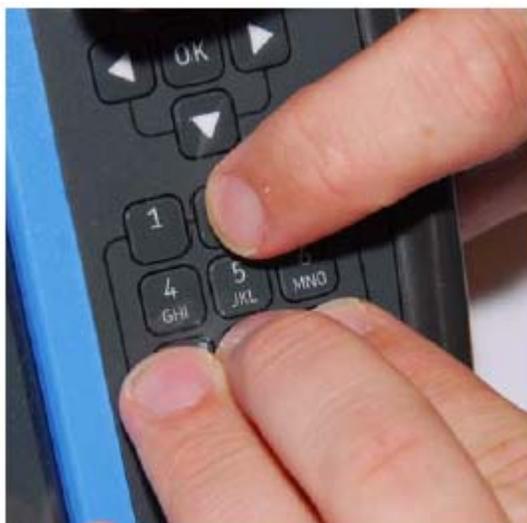
Figure 4. Perform a soft reboot

- Next, perform a soft reboot of the TKSA 60/80 by holding down the **2, 7, 8, 9** keys simultaneously [Figure 4] until the screen changes.

The new calibration file will not be applied until a reboot is performed.

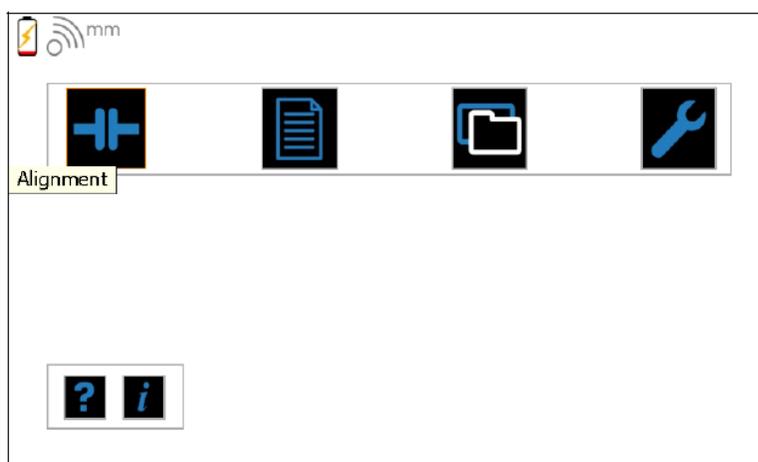
Figure 5. Start screen

- The new calibration file will be copied over onto the Display Unit during the reboot process, and will not be reported to the user. When the start screen of the TKSA 60/80 application is displayed [Figure 5], the installation process has completed successfully.
