Knowledge Base Article

Product Group: Alignment Product: TKSA 60, TKSA 80 Shaft Alignment Systems Version: N/A

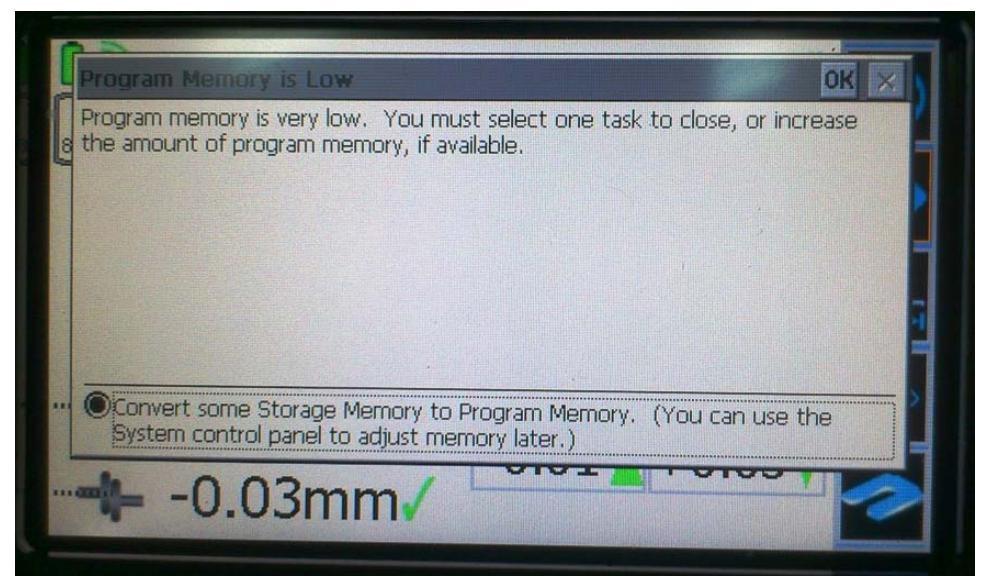
There is a known issue in the SKF TKSA Shaft Alignment System that causes a 'low memory' error to be displayed. [Figure 1]

Figure 1. Program Memory is Very Low

This error has only been seen after 50+ jobs have been run on a TKSA device consecutively without a reboot. As the unit reboots daily, it was never raised as more than a low priority defect.

In order to resolve the issue, do a soft reset on the device by pressing 2+7+8+9 simultaneously.

If a soft reset cannot be done, it may be that the unit is unable to process the key press events due to the low memory state.

If that is the case, perform a hard reset by using a pin to press the reset inlet located under the USB ports cover.
