Knowledge Base Article

Product Group: Microlog
Product: Microlog AX CMXA 80
Version: N/A

This article explains the most probable reason for the SKF Microlog error, "Failed to read from EEPROM. Incorrect OEM IDs...Please contact your distributor for more information."

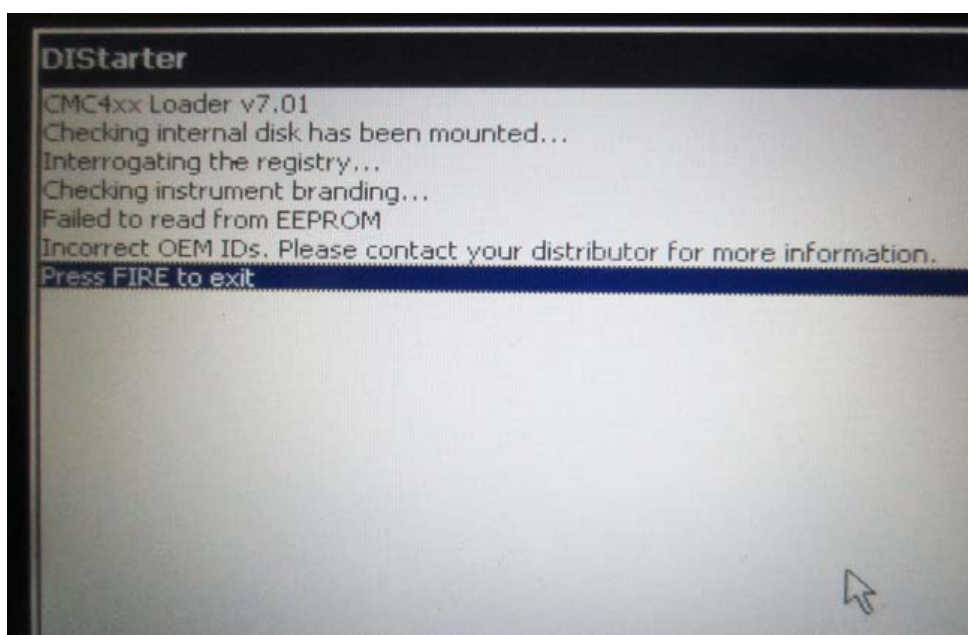
When the error shown in Figure 1 is encountered, more than likely it is due to a fault in the battery.

Figure 1. Failed to read from EEPROM error

Try replacing the CMAC5070 (BP-15) battery, as this may be the cause of the fault. If the battery has a faulty I2C bus, then this affects the reading of the Dallas IC since this also uses the I2C bus.

If a different BP-15 battery can be tested with the unit and the Microlog no longer displays the error, then a new CMAC5070 (BP-15) replacement battery should be purchased.

If there is no spare CMAC5070 (BP-15) battery available, then try removing the CMAC5070 (BP-15) battery from the Microlog and using the Power Supply and/or Docking Station to power the Microlog.
