# Knowledge Base Article

Product: CMVL 4000-ML; CMVL 4000-EN Wireless MicroVibe

## Abstract

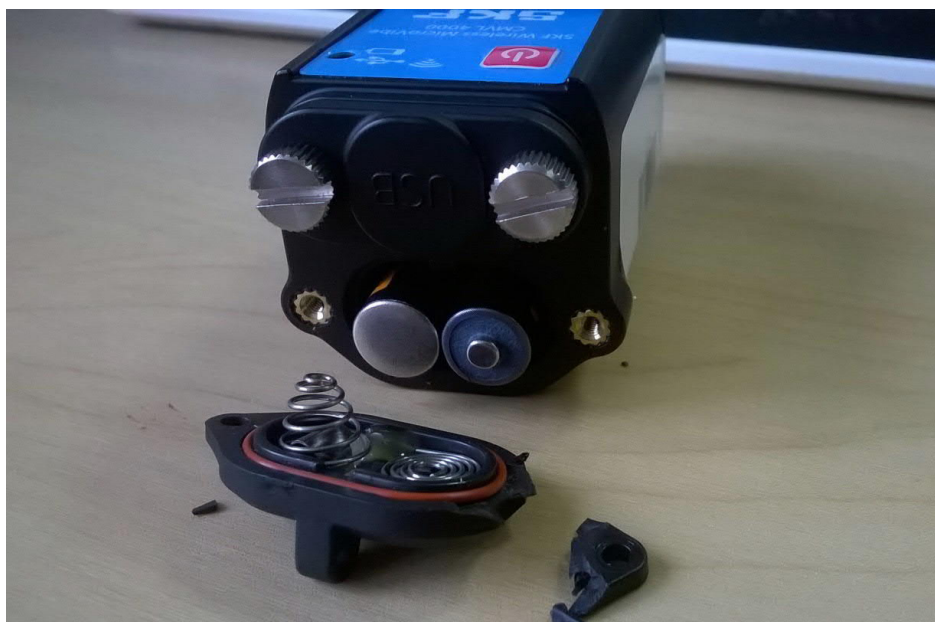
If the two screws on the battery cover of the SKF Wireless MicroVibe are over-tightened, the ears may break off. [Figure 1]

Figure 1: Wireless MicroVibe unit showing battery cover with broken ear

The unit does NOT have to be sent in to the factory.

If the unit is under factory warranty, please contact the Technical Support Group (TSG) for a replacement battery cover, free of charge.

If the unit has exceeded its one-year factory warranty, please contact our Customer Service Group (CSG) to order replacement battery cover.

The accessory part number is CMAC 4045 battery cover (includes the screws). [Figure 2]

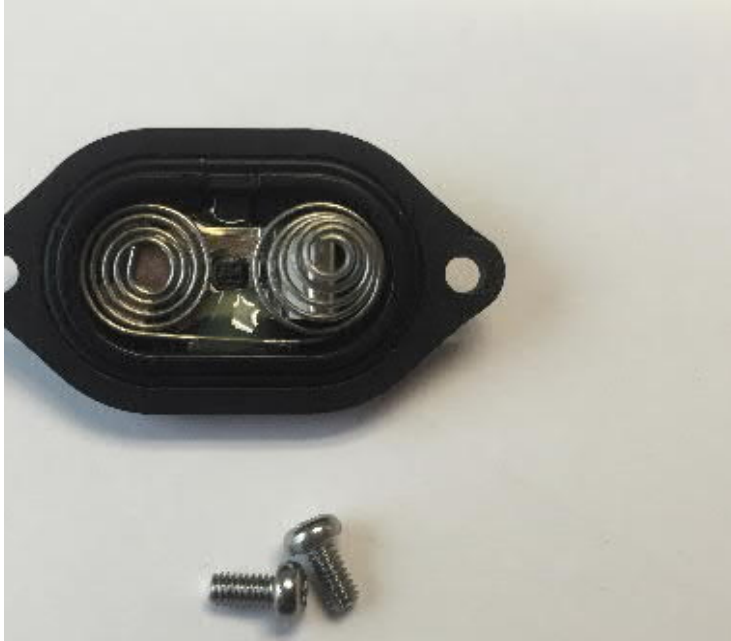
Figure 2. New CMAC 4045 battery cover and screws
