Knowledge Base Article

Product: CMAC 5030-K (Laser Tachometer)

Abstract

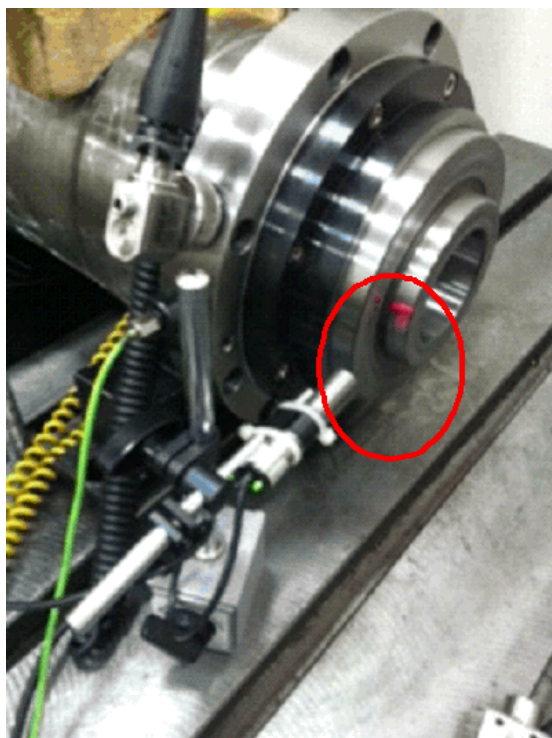
It was determined that the customer reporting the issue had the CMAC 5030-K laser tach about 2-3 inches off the target (reflective tape). [Figure 1]

Figure 1. Customer installation

The CMAC 5030-K has a longer focal length and should not be placed closer than 10 inches to the rotating assembly. Putting the body closer means the beam will have to be tuned by rotating the tachometer body.

The customer in this case was able to position the CMAC 5030-K laser further away from the target (more than 10 inches), and it was able to trigger perfectly.
