Monitoring Felt for Improved Paper Quality

A paper machine – case study

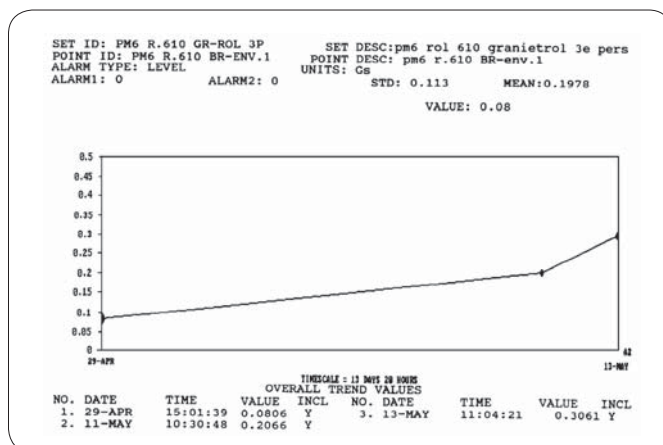
Using the overall acceleration envelope value as the trend criterion, data was continuously collected over a two week interval. **Fig. 3** displays the overall acceleration envelope trend from 13 April to 29 April. It was apparent that there were problems in this section of the paper making process, since a sharp upward trend was evident along with a three fold increase in overall value. The envelope spectrum was analyzed (→ **fig. 4**) and further confirmed the hypothesis that a felt seam discontinuity was producing impact forces at the press nip under observation.

Fig. 3. Vibration acceleration enveloping overall trend.

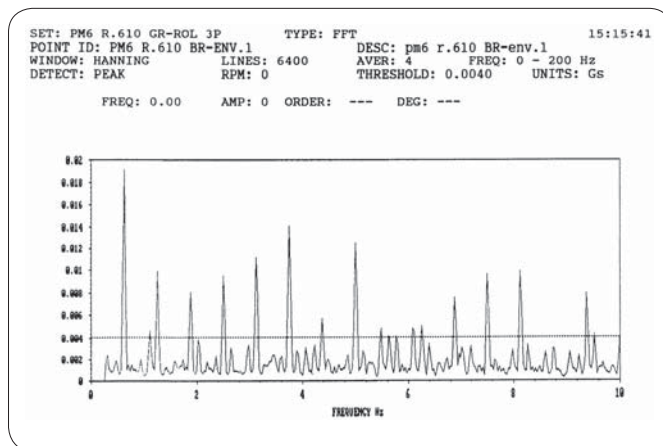
Fig. 4 clearly shows a harmonic series of peak amplitudes, spaced at the repetitive rate of the felt loop. Under ideal felt conditions, significant impacts would not be produced and neither the acceleration envelope upward trend nor the harmonic peak series spectrum would be present at such levels.

Fig. 4. Single spectrum plot – Acceleration enveloping spectrum indicating felt anomalies.

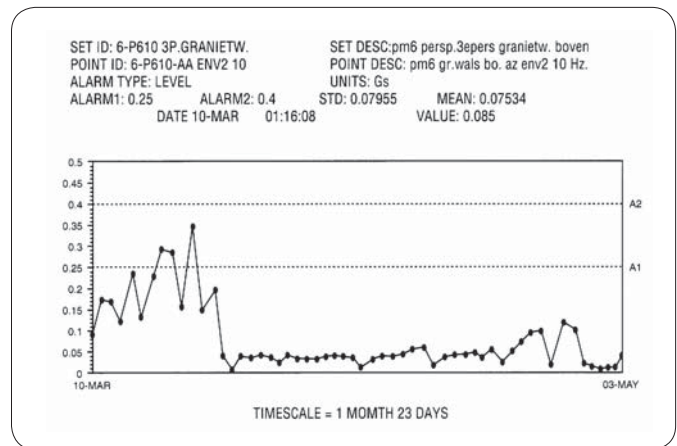
Fig. 6 is an interesting trend diagram showing the overall acceleration envelope level of the same crown roll nip one year later. A higher than normal level is seen between 10 March to 24 March when the felt was replaced. Following that week, the lower overall trend provides a confirmation of normal operation.

Fig. 6. Overall value versus time trend – Long term trend after corrective maintenance.

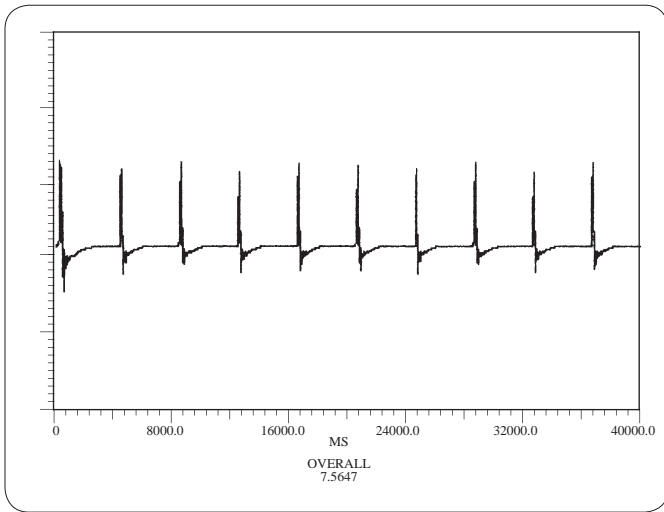
Fig. 12 shows the demodulated signal with only the enhanced impulse present. Fig. 13 is the FFT spectrum of the output of the envelope, illustrating the impulse signal repetitive peaks.

Fig. 12. Enveloped time domain.
