CMVA 60 ULS SKF Microlog – Drill Platform Anchor Winches

By Dr. Bob Jones • SKF

PUB CM3050 EN · August 2011

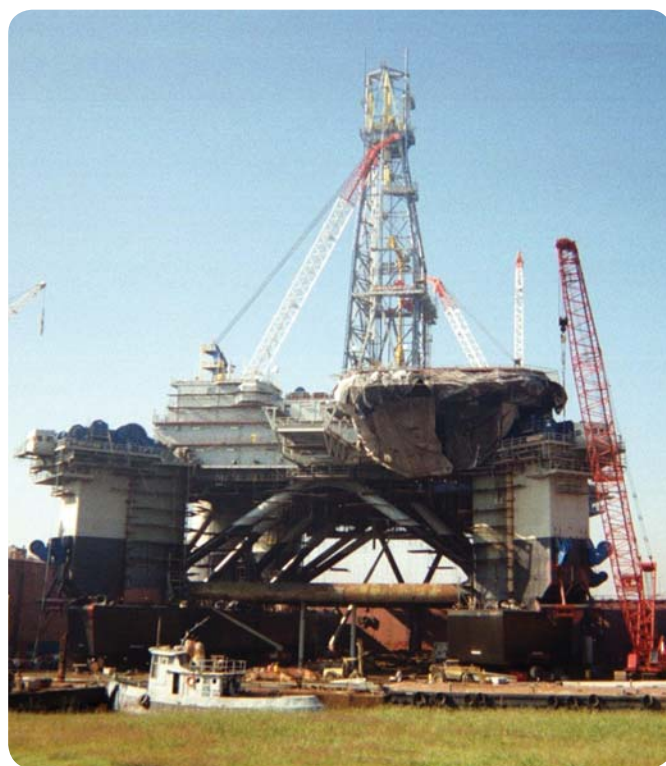
The cable and anchor chains weigh approximately 149 kg/m (100 lbs./ft.) so that the cable winch is a massive device of over 113 000 kg (250 000 lbs.). The cable drum, which is electrically driven through a gearing arrangement, has the support bearings mounted into the inside radius of the drum, resulting in a rotating outer ring for the bearing and a stationary drum shaft.

Fig. 2. Anchor cable drum.

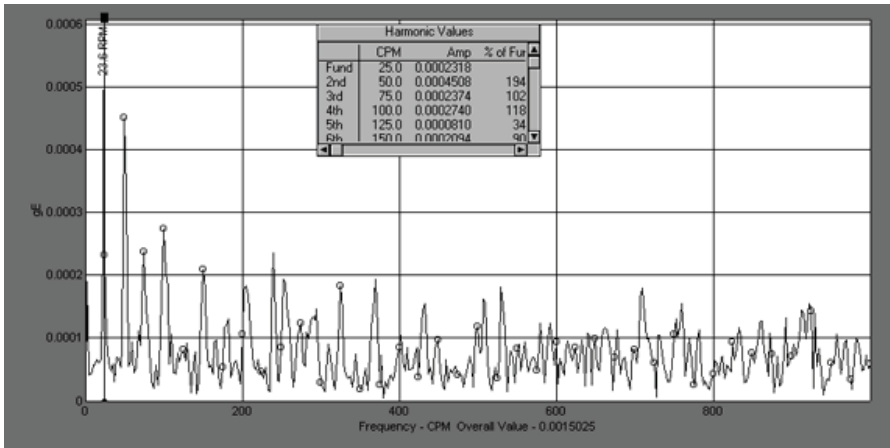
Fig. 3. taken on an SKF 23292CA, is one of the spectrums we collected that seemed to indicate a damaged inner ring. The fundamental frequency is marked at 23,6 CPM and it has multiple harmonics. Although the frequency was 0,9 different, the visual evidence was compelling; in addition, the r/min was calculated with a wristwatch.

Although the amplitudes are extremely low, one must remember that enveloped acceleration amplitudes are speed dependent. Laboratory testing has shown that a flaw in a bearing rotating at 50 r/min produces an amplitude of 0,004 gE. This same flaw produces an amplitude of 1,7 gE at 3 600 r/min. In addition, a bearing flaw will generate a truncated sine wave, which when processed with a Fourier Transform, will show the fundamental frequency plus harmonics.

Fig. 3. Frequency spectrum of an SKF 23292CA, inner ring rotation at ~2,4 r/min. Winch number 2.

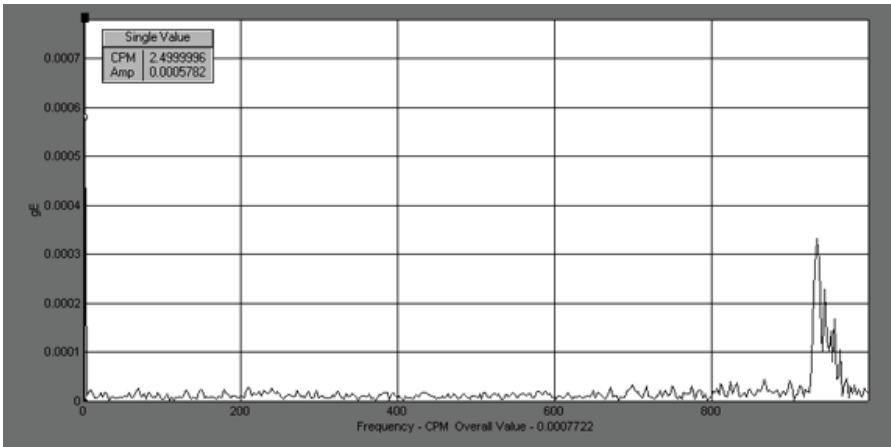
In **fig. 4**, the flat line for the last 2 to 3 seconds is the results of the welding machine dropping off line stopping the rotation. In comparison, **fig. 5** is data collected on another SKF 23292 where no damage was detected. All point setup parameters remained the same.

There is energy shown above 950 CPM, but this is not attributed to the bearing.

Fig. 5. Frequency spectrum of SKF 23292 on winch number 3.
