# Improving Motor Quality by Trim Balancing

By Gary Herr • Demaria Electric Motor Services Inc.

PUB CM3047 EN · July 2011

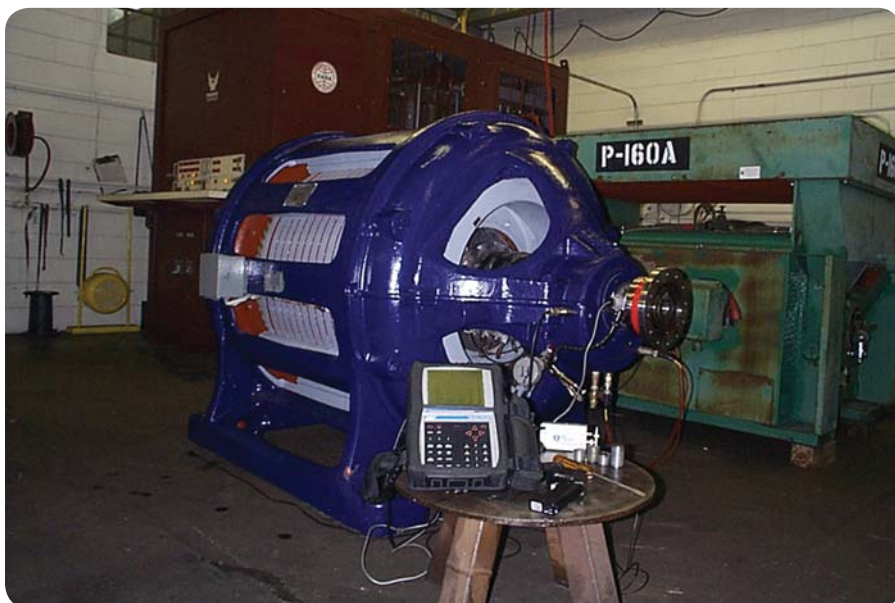
**Fig. 1.** Trim balancing 1 250 HP electric motor with CMVA 60 SKF Microlog data collector.

Demaria Electric Motor Services Inc., in Wilmington, California, incorporates the SKF Condition Monitoring model CMVA 60 data collector with its built in Balancing Wizard to trim balance assembled motors in place at running speed (→ **fig. 1**).

The SKF Microlog Balancing Wizard is now used to perform a two-plane dynamic balance. Following the wizard's steps of the reference run, trial runs, correction run and possible trim runs ensure remarkable results. If the trial weights do not influence the rotor properly, the wizard prompts the user to move the weight or add more weight. Once trial runs are complete, the SKF Microlog calculates the influence coefficients and offers the amount of balance correction weights and the angles to place them. Weights are then cut from all-thread stock and a screw driver slot is machined on one end for installation (→ fig. 2). If the results of the correction run are satisfactory, you may end the routine; if not, follow the prompt to further trim the rotor. Continuing with the trim run will often lower the 1x running speed amplitudes to below 0.005 inches per second (peak).

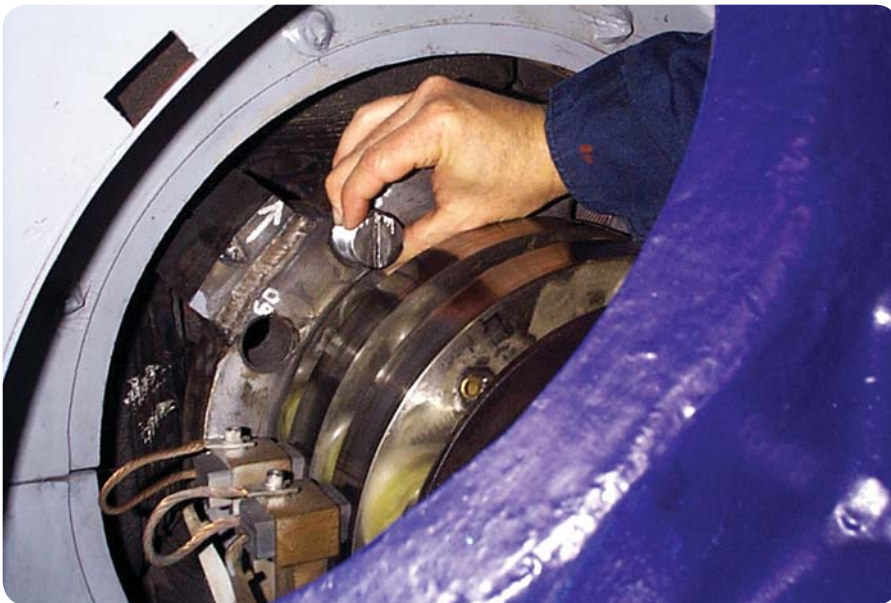
**Fig. 2. Adding a trim weight to the field balance ring. Note the slow speed balance stand weight welded on top of the balance ring in order to keep the balance ring holes open for trim balancing.**

The rotor is then balanced in a balancing machine. Weight is welded to the top of the balancing rings to keep the twelve 1.25 in. threaded holes free for subsequent shop and field balancing. The motor is then assembled and set up to run on the test floor. Balancing holes are marked precisely in 30 degree increments. The motor is run under normal synchronous uncoupled conditions until amplitudes and phase angles stabilize.
