Industry: Financial Processing Center, Hospitals, Airports, etc. Machine Type: Emergency Diesel Generators

History

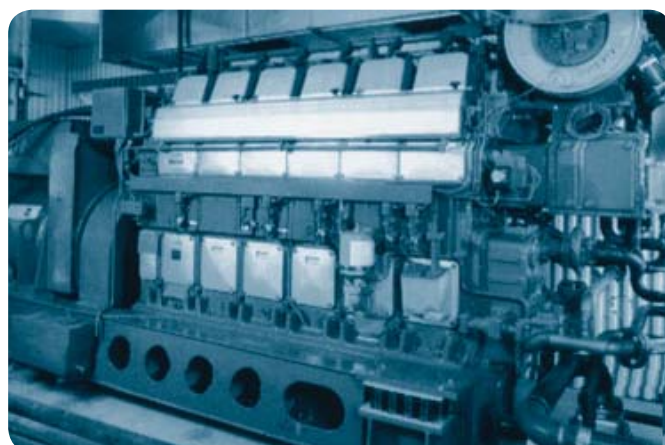
Inspection of the generators determined that the injector tips were badly fouled and the fuel filters were plugged with a black slimy residue.

A fuel filter, injector and fuel samples from the top, middle and bottom of the main fuel storage tank were analyzed. Laboratory analysis of the top and middle fuel samples were clean and of good quality. Analysis of the bottom fuel sample showed a free water layer. Microbial analysis showed large amounts of algae in the oil and water. Lab analysis showed the residues to be algae.

- Analyzes their diesel fuel quarterly for water, algae and oxidation
- Treats the diesel fuel regularly with algaecides, biocides and anti-oxidants
- Inspects the tanks periodically for proper maintenance
- Filters (polishes) the stored diesel fuel to remove water, dirt, contaminants and algae if any evidence of contamination is found
